## RURAL BUILDING

# Reconditioning of silage clamps

Practical trials have shown that the treatment of silage clamp floors with a second layer consisting of aerated concrete applied with the aid of a newly developed surfacefinisher gives a long-life and costefficient renovation.

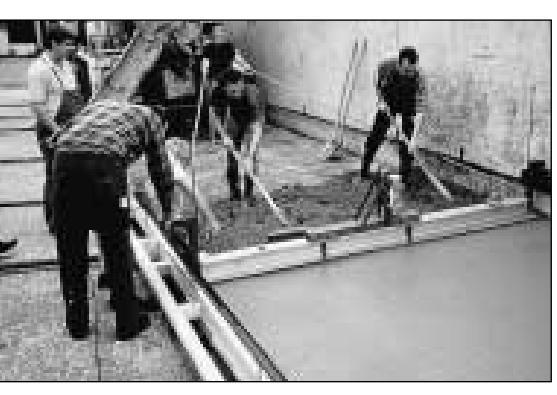
Fig. 1: Concreting preparations on the Meiereihof

The necessary surface-finisher for treating the flooring represents in principal a vibrating beam. Its concrete-consolidating effect is based on direct application of the vibration onto the concrete surface. The concrete area is pressed forward through continuous application of this equipment. Its operation within silage clamps requires a basic conception involving the following components (*fig. 1*):

for concreting. The concrete was then smoothed by a third helper pulling slowly on the cable of the finisher machine (*fig. 1*).

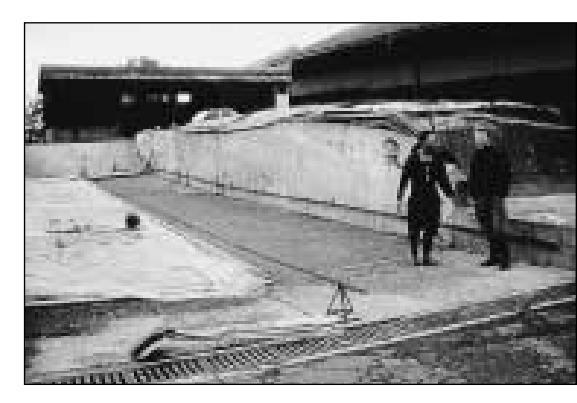
Fig. 2: Post-concreting treatment through covering

Once the brought-in concrete was smoothed, the operation was repeated with the next load. In this way, a complete stretch was seamlessly concreted. Working time for the 22 m long and 3 m wide stretch was around 1.5 hours. Plastic sheeting was laid over the concrete for complete hydration and for protection against the weather (*fig. 2*).
